Tape Guide Pin Roller Revision

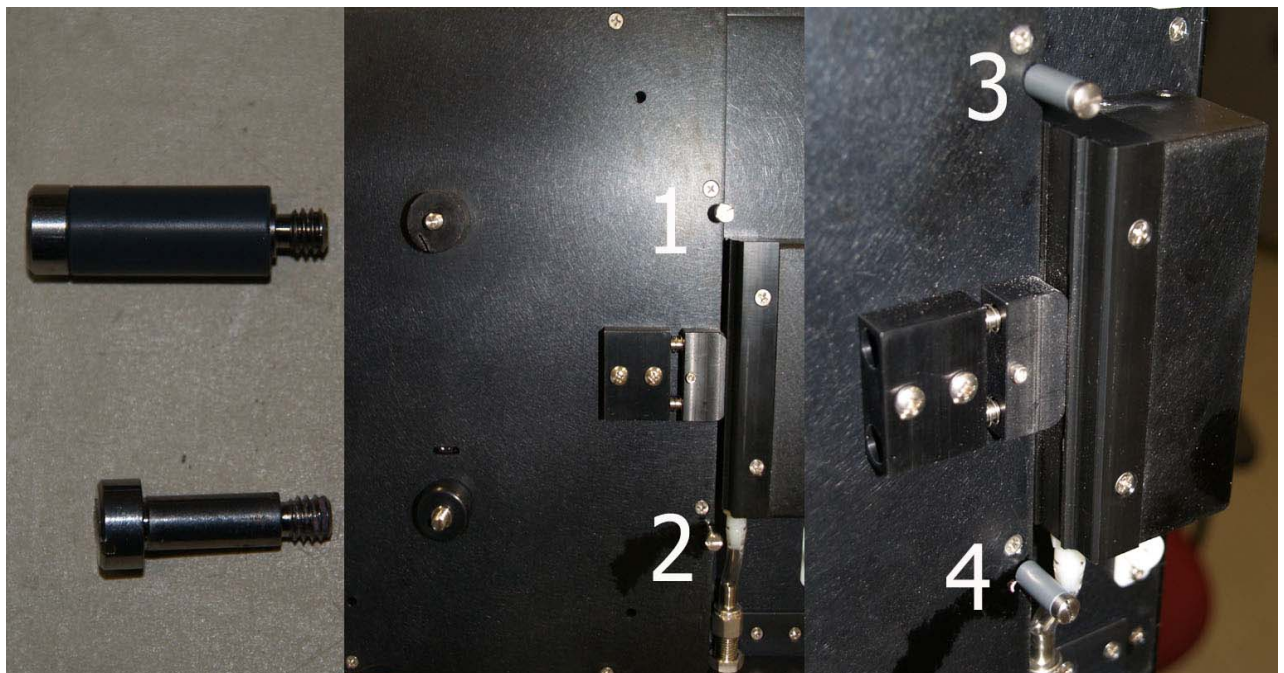
The cause of these problems was found to be excessive friction caused by the stainless steel guide pins above and below the sample chamber used for tape alignment.

LEFT: The new guide pin with roller (top) and the old guide pin (bottom).

CENTRE: The position of the upper guide pin (1) and lower guide pin (2)

RIGHT: The new upper guide pin (3) and lower guide pin (4) installed above and below the sample chamber.

This issue can be resolved by installing longer guide pins with a PVC roller installed over top of the pin. This roller reduces the friction between the tape and the guide pin, allowing the tape to be taken up on the take-up reel correctly.
